REPORT  
OF A  
FIRE, LOAD and WATER TEST

MADE UPON A  
TRIANGULAR REINFORCED CONCRETE  
FLOOR SYSTEM

CONSTRUCTED BY  
THE AMERICAN STEEL AND WIRE COMPANY

AT THE  
FIRE TESTING STATION  
COLUMBIA UNIVERSITY, NEW YORK CITY

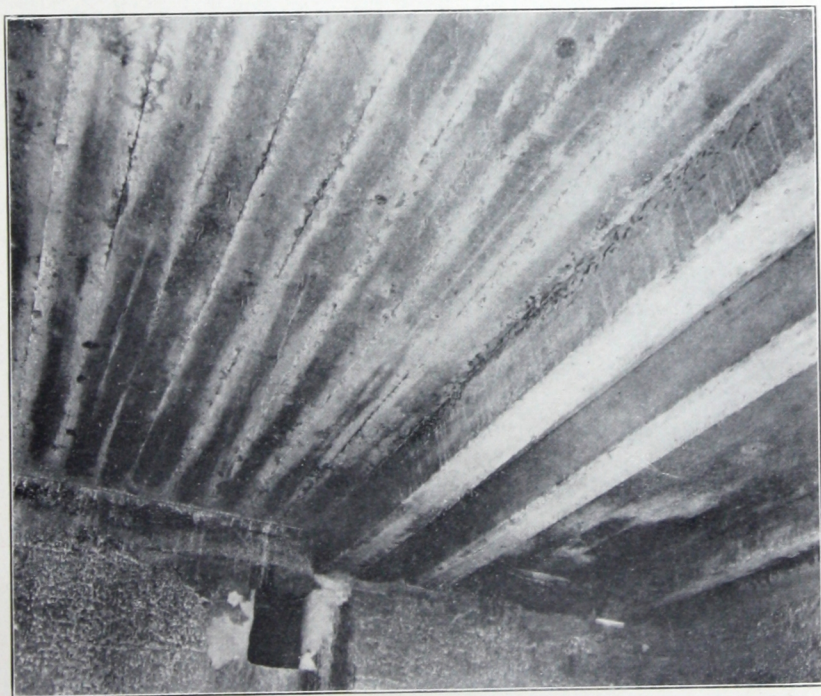
Underside of Floor before Test, showing two Middle Beams, and 8 ft. span.

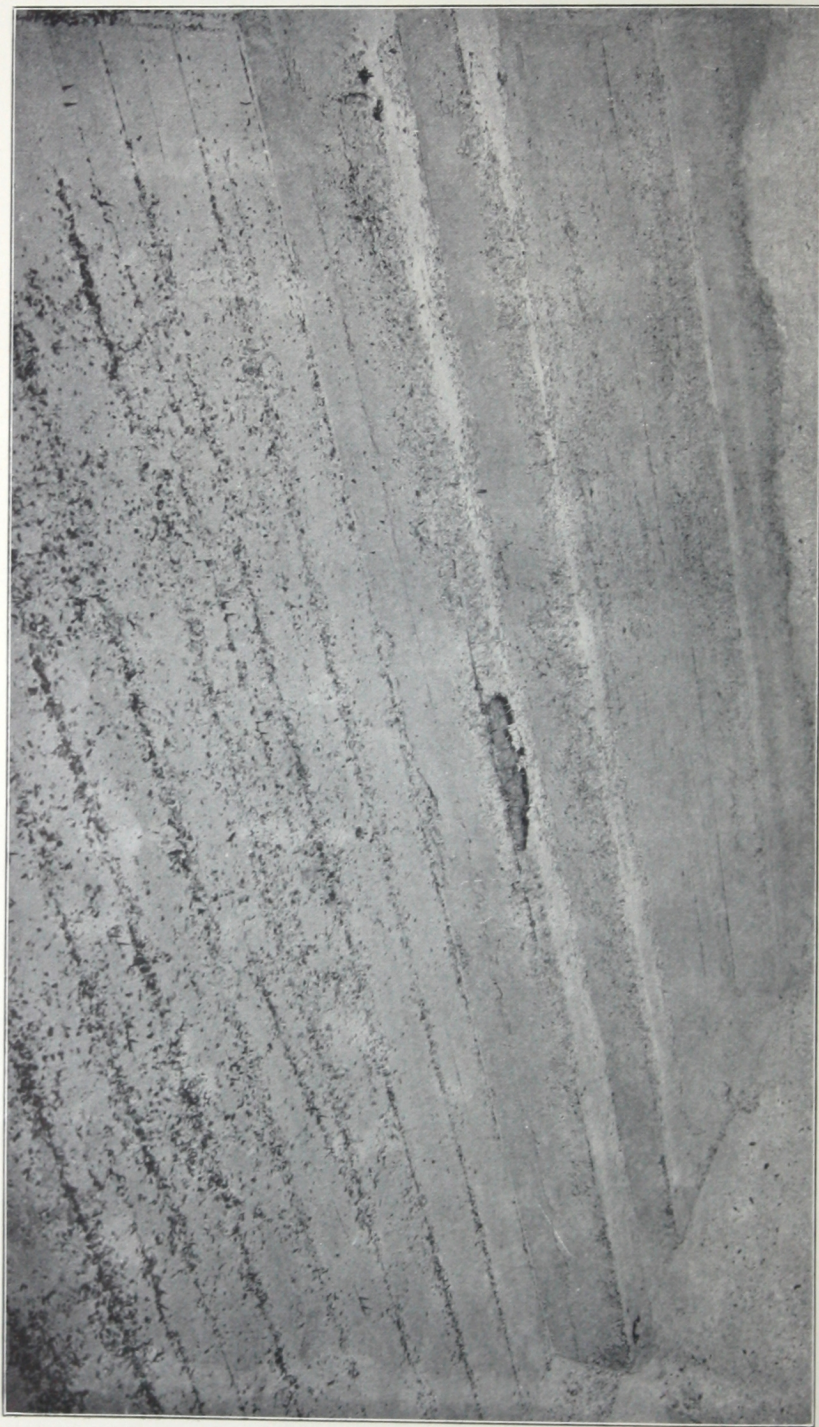
UNDERSIDE OF FLOOR AFTER TEST.

All of these cracks were evidently due to expansion. They appeared to be on the upper surface only. The underside of the floor or ceiling of the test chamber was in perfect condition so far as could be observed up to the application of water. The water scored the surface somewhat in front of the doors where its action was most severe, but only to a depth of about one inch as a maximum. Considerable of the concrete thus washed out was along the line of the cracks between the centering boards where the cement had evidently been carried away by the escaping water at the time the floor was placed. This is a defect that could be easily avoided.

The wire mesh encasing the bottom of the middle I beam of the eight foot span was exposed for about three feet near the middle of the beam, and the flange of the beam itself was bare for 18 inches. This was the only metal exposed by the application of water.

There was one crack four feet long in the central portion of the eight foot span about one foot from the middle beam and running parallel with it.

There were several small cracks across the bottom of the beams, but the concrete remained firm and secure.

As a whole the ceiling was in excellent condition at the completion of the test.

Condition of 8 ft. span shown at top of picture. Beams in the middle, and 5 ft. span beyond.
